## NATIONAL ENERGY BOARD

Report In The Matter of a Public Inquiry  
Into an Accident on the Pipeline System  
of Sun Pipe Line Company Near the  
St. Clair River Crossing  
in October 1986 Near Sarnia, Ontario

March 1987

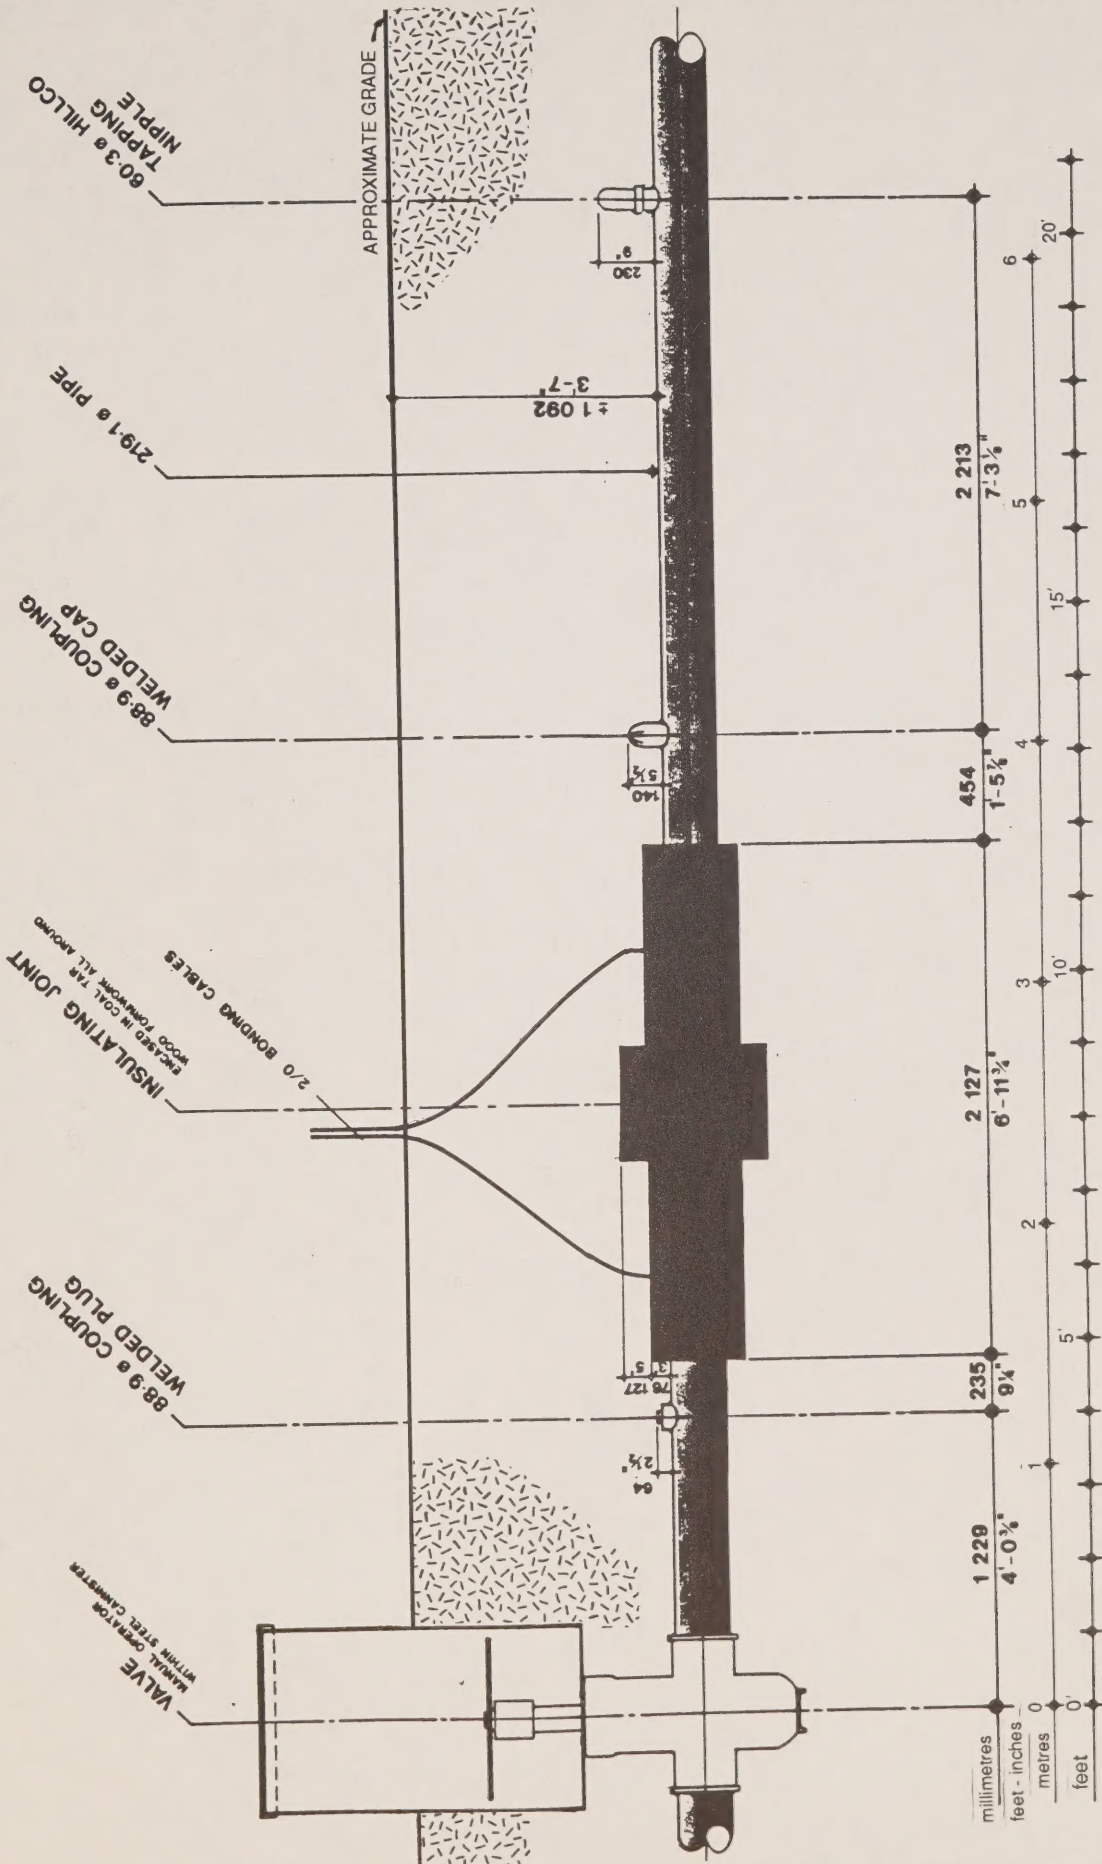
## PIPE SECTION

Mr. R. DiCocco then positioned the backhoe with a track on either side of the line and began to excavate a trench over the line one bucket wide, approximately eight to ten feet in length. Each cut was one foot deep. Mr. Schultz used the probing bar after each cut. Following the second cut, when Mr. Schultz had hit something hard with the probe bar, Messrs. M. DiCocco and Rocco hand excavated at that location and exposed the insulating flange box and the eastern-most bond cable shown in Appendix D.

At this point, the evidence is unclear as to which of two fittings, a coupling welded cap or a Hillco tapping nipple, was located and marked. Messrs. DiCocco and Rocco stated that the coupling welded cap was hand-exposed at the same time as the insulating joint and marked with a shovel. A trench was dug on either side of the pipe, the backhoe was moved further east eight to ten feet and trenching was again begun over the pipe. Messrs. DiCocco and Rocco testified that no other fittings were uncovered.

Mr. Schultz stated that, following the hand-exposure of the insulating flange box, the backhoe was moved approximately ten feet further east to continue excavation over the pipe. Probing after these cuts located the pipe near the end of this trench. Hand-digging at that location exposed the Hillco fitting which was marked with a shovel. Mr. Schultz testified that the coupling welded cap had not been exposed. After the backhoe had been moved, Mr. Schultz gave instructions to Mr. M. DiCocco to widen the trench to the south of the line. Mr. Smith had finished locating the Bell cable to the west of the valve cannister and motioned to Mr. Schultz that he wished to discuss the location with him. Mr. Schultz left the trench to talk to Mr. Smith

who was standing near his van at the roadway, some eight to nine metres southwest of the backhoe. Mr. R. DiCocco had begun to use the backhoe to remove excess dirt between the flange and the Hillco fitting.

Messrs. Schultz and Smith had been discussing the location of the telephone lines for approximately 30 seconds when, at 1001 hours EDT, the bucket of the backhoe hit the Hillco fitting approximately 18.2 cm above the top of the pipe, causing a release of butane. Messrs. M. DiCocco and Rocco were thrown from the ditch and made their way to the St. Clair Parkway. They were picked up by a passing motorist and driven to the Shell Emergency Unit, approximately 600 m south of the accident site.

A PLIDCO repair sleeve was bolted to the pipeline at the location of the damaged Hillco tap. The mainline valve adjacent to the incident site was opened and the water batch was pumped through to
